# Walk Around

## Focke-Wulf Fw 190A/F

Walk Around Number 22  
squadron/signal publications

By Malcolm Laing and E. Brown Ryle

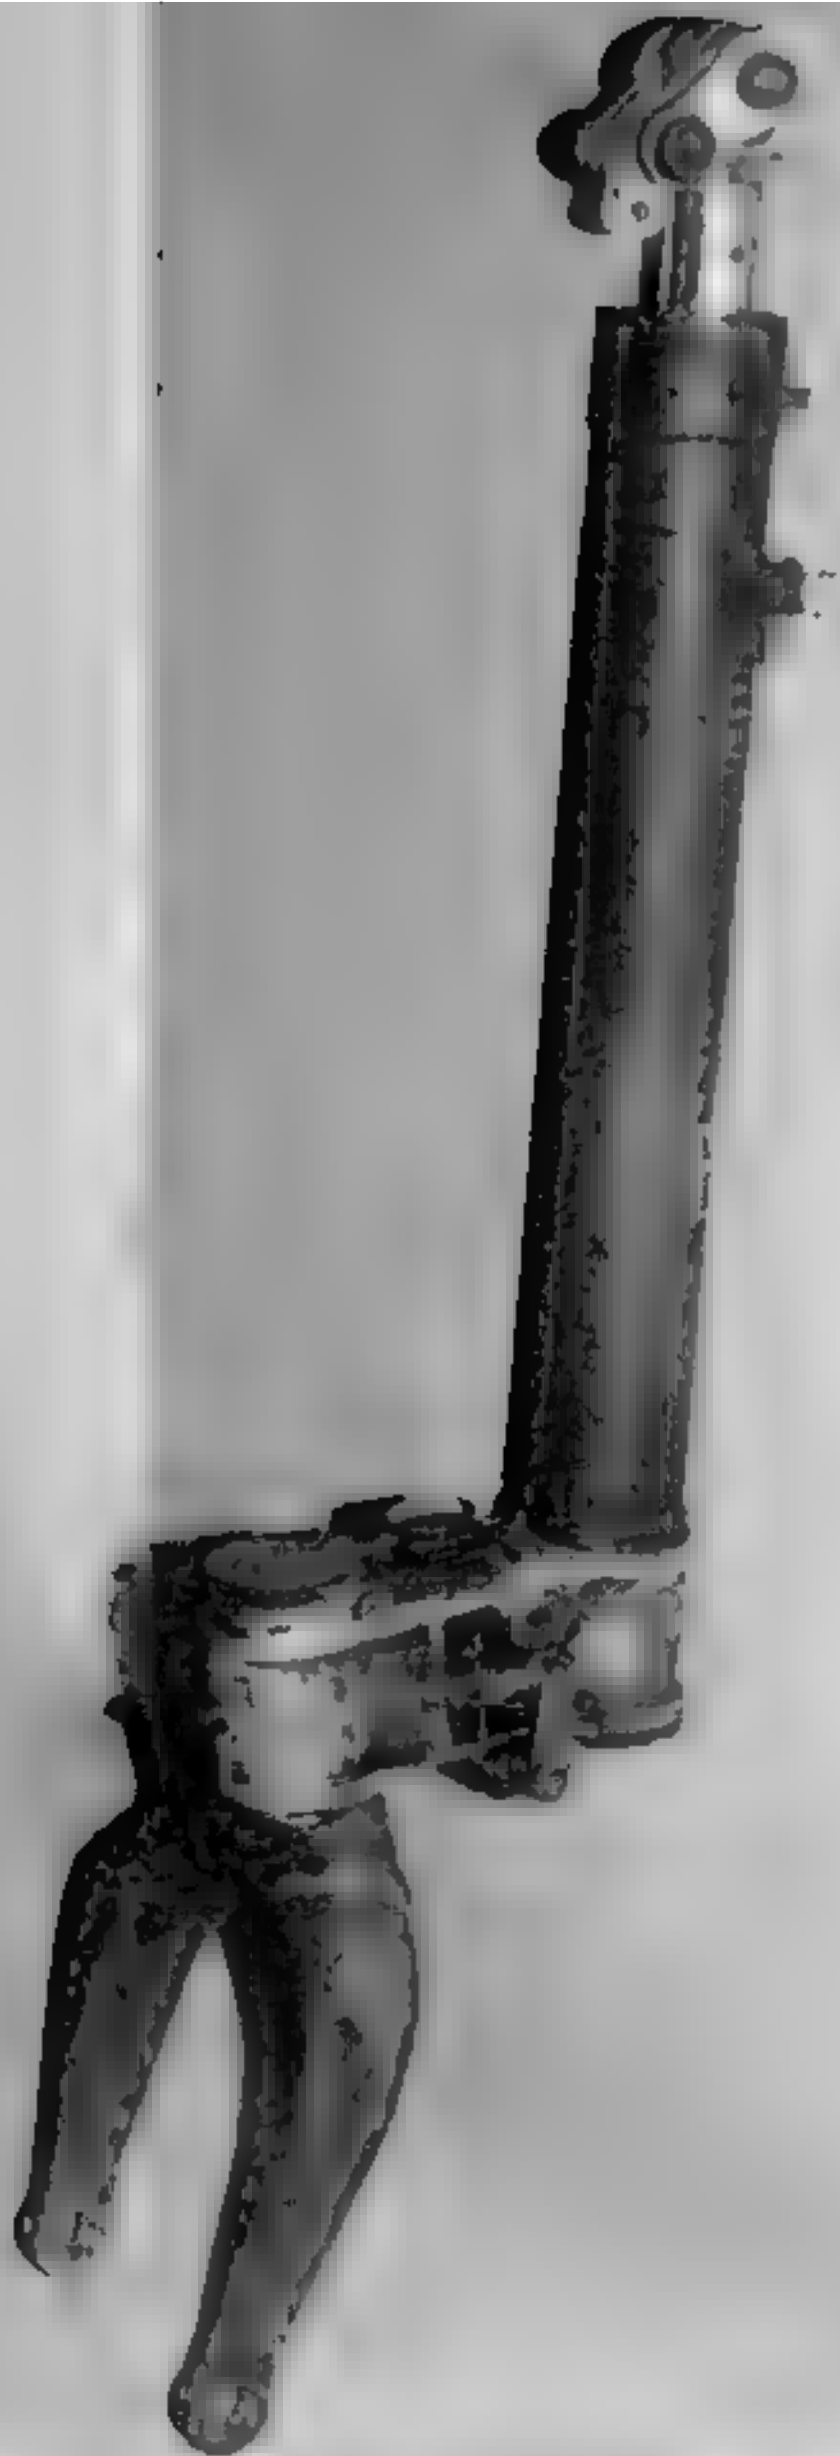
A complete tail wheel shock and fork assembly, about to undergo restoration, displays years of age and wear. This assembly was a later style and the air fitting was moved to the upper front portion of the shock. This tail wheel fork is turned 180° from its normal position. (Laing)

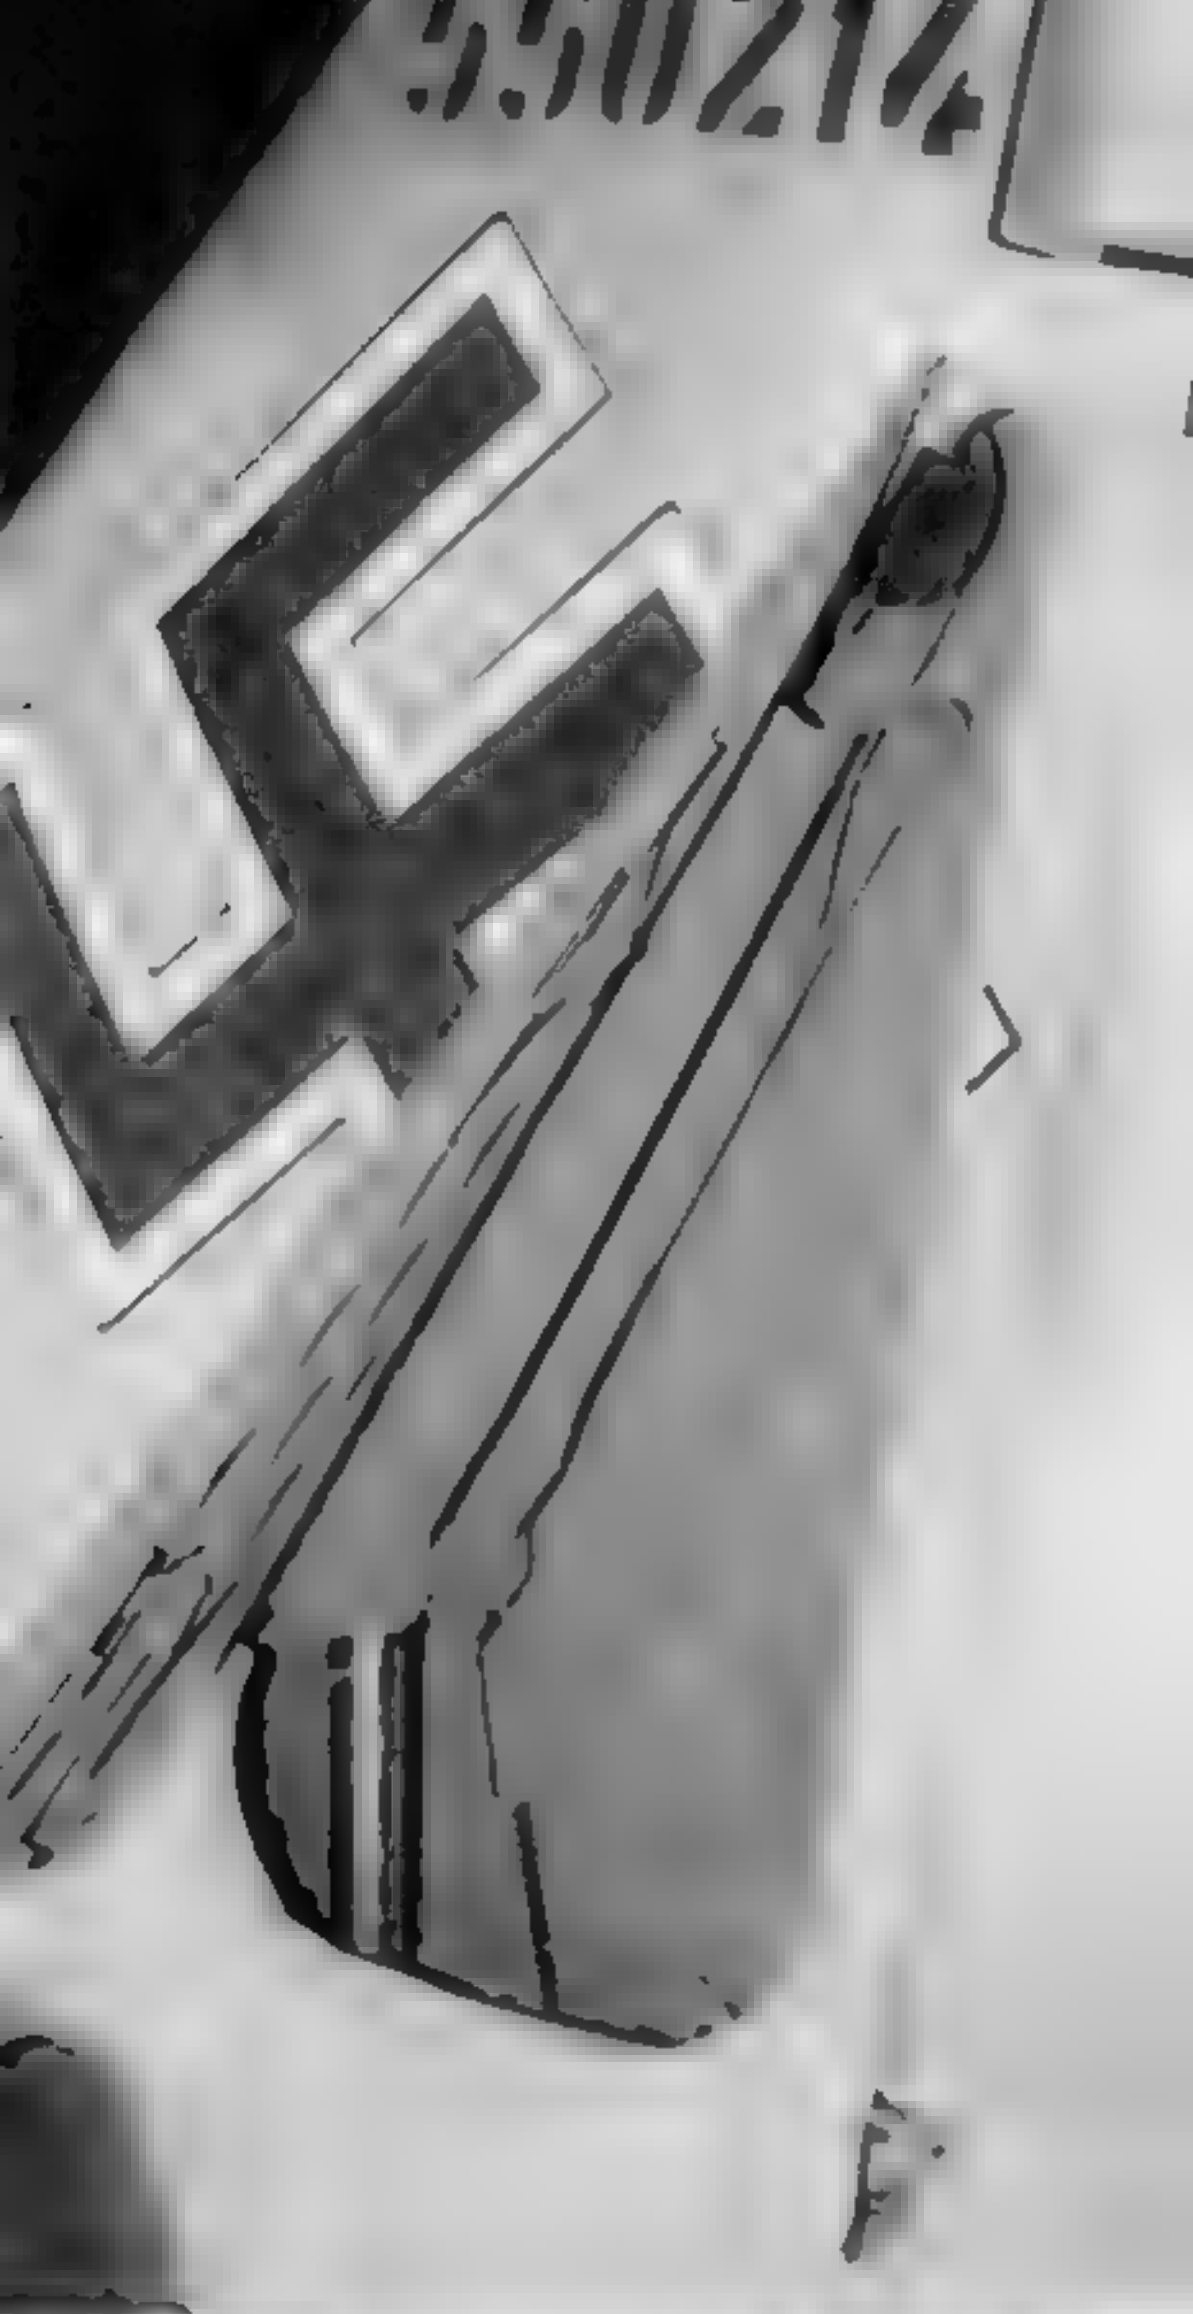
The triangular access door on the Fw 190's vertical stabilizer allowed access to the tail wheel retraction system and rudder control cables. The upper portion of the tail wheel shock absorber and the extension spring is in the lower forward portion of the housing. The tail wheel retraction wire runs over the roller at the top of the opening and proceeds to the top of the spring. (Molnar & Hugo)

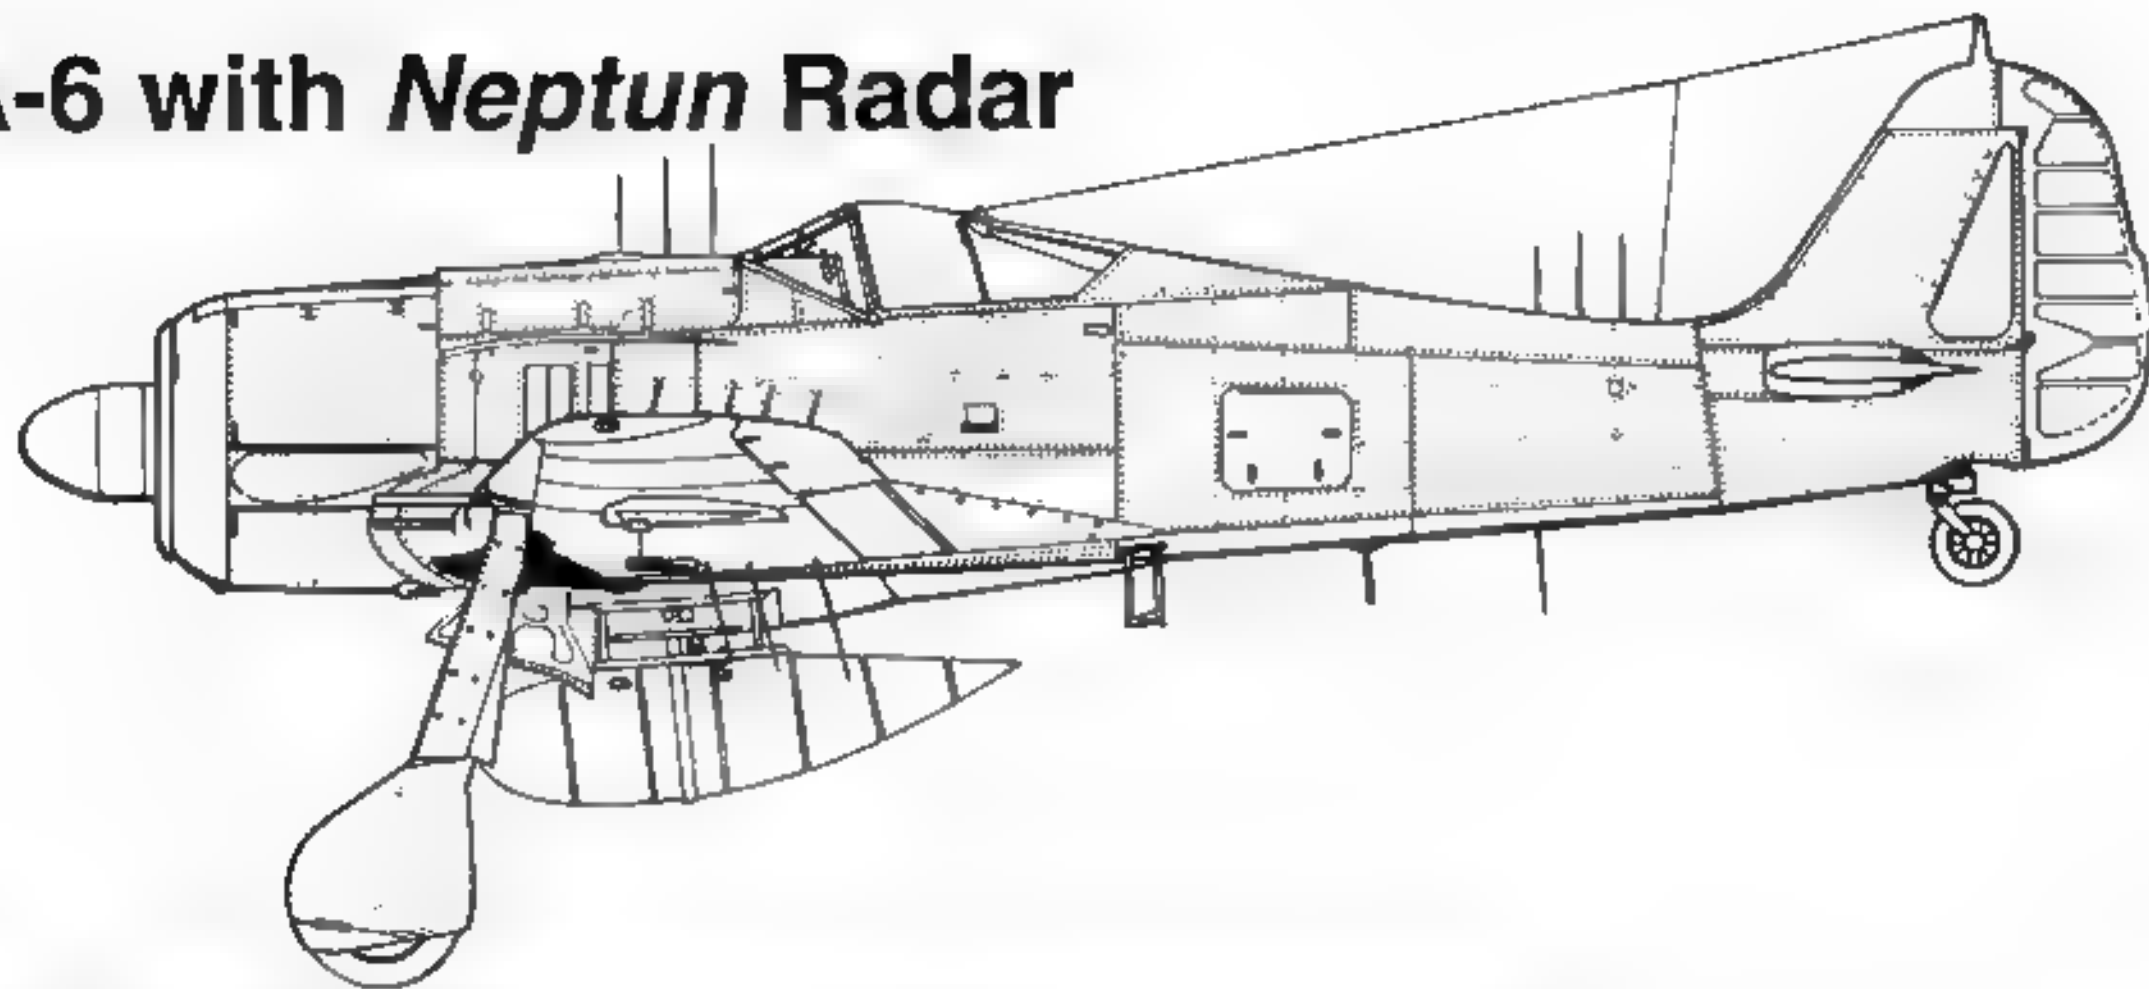
# Fw 190A-6 with *Neptun* Radar

## Focke-Wulf Fw 190A-6 Specifications

**Wingspan:** 34 feet 5 inches (10.5 m)  
**Length:** 29 feet 4.6 inches (8.9 m)  
**Height:** 12 feet 11 inches (3.9 m)  
**Empty Weight:** 6393.3 pounds (2900 kg)  
**Maximum Weight:** 9054.2 pounds (4107 kg)  
**Powerplant:** One 1730 hp BMW 801D-2 twin-row, 14 cylinder, air-cooled radial engine

**Armament:** Two fuselage mounted 7 92mm MG17 machine guns with 900-1000 rounds per gun; two wing-root 20mm MG151/20E cannons with 200-250 rounds per gun; two outboard wing 20mm MG151/20E cannons with 125 rounds per gun.  
**Maximum Speed:** 410.1 mph (660 kmh) at 22,965.9 feet (7000 m)  
**Service Ceiling:** 34,448.8 feet (10,500 m)  
**Maximum Range:** 310.7 miles (500 km)

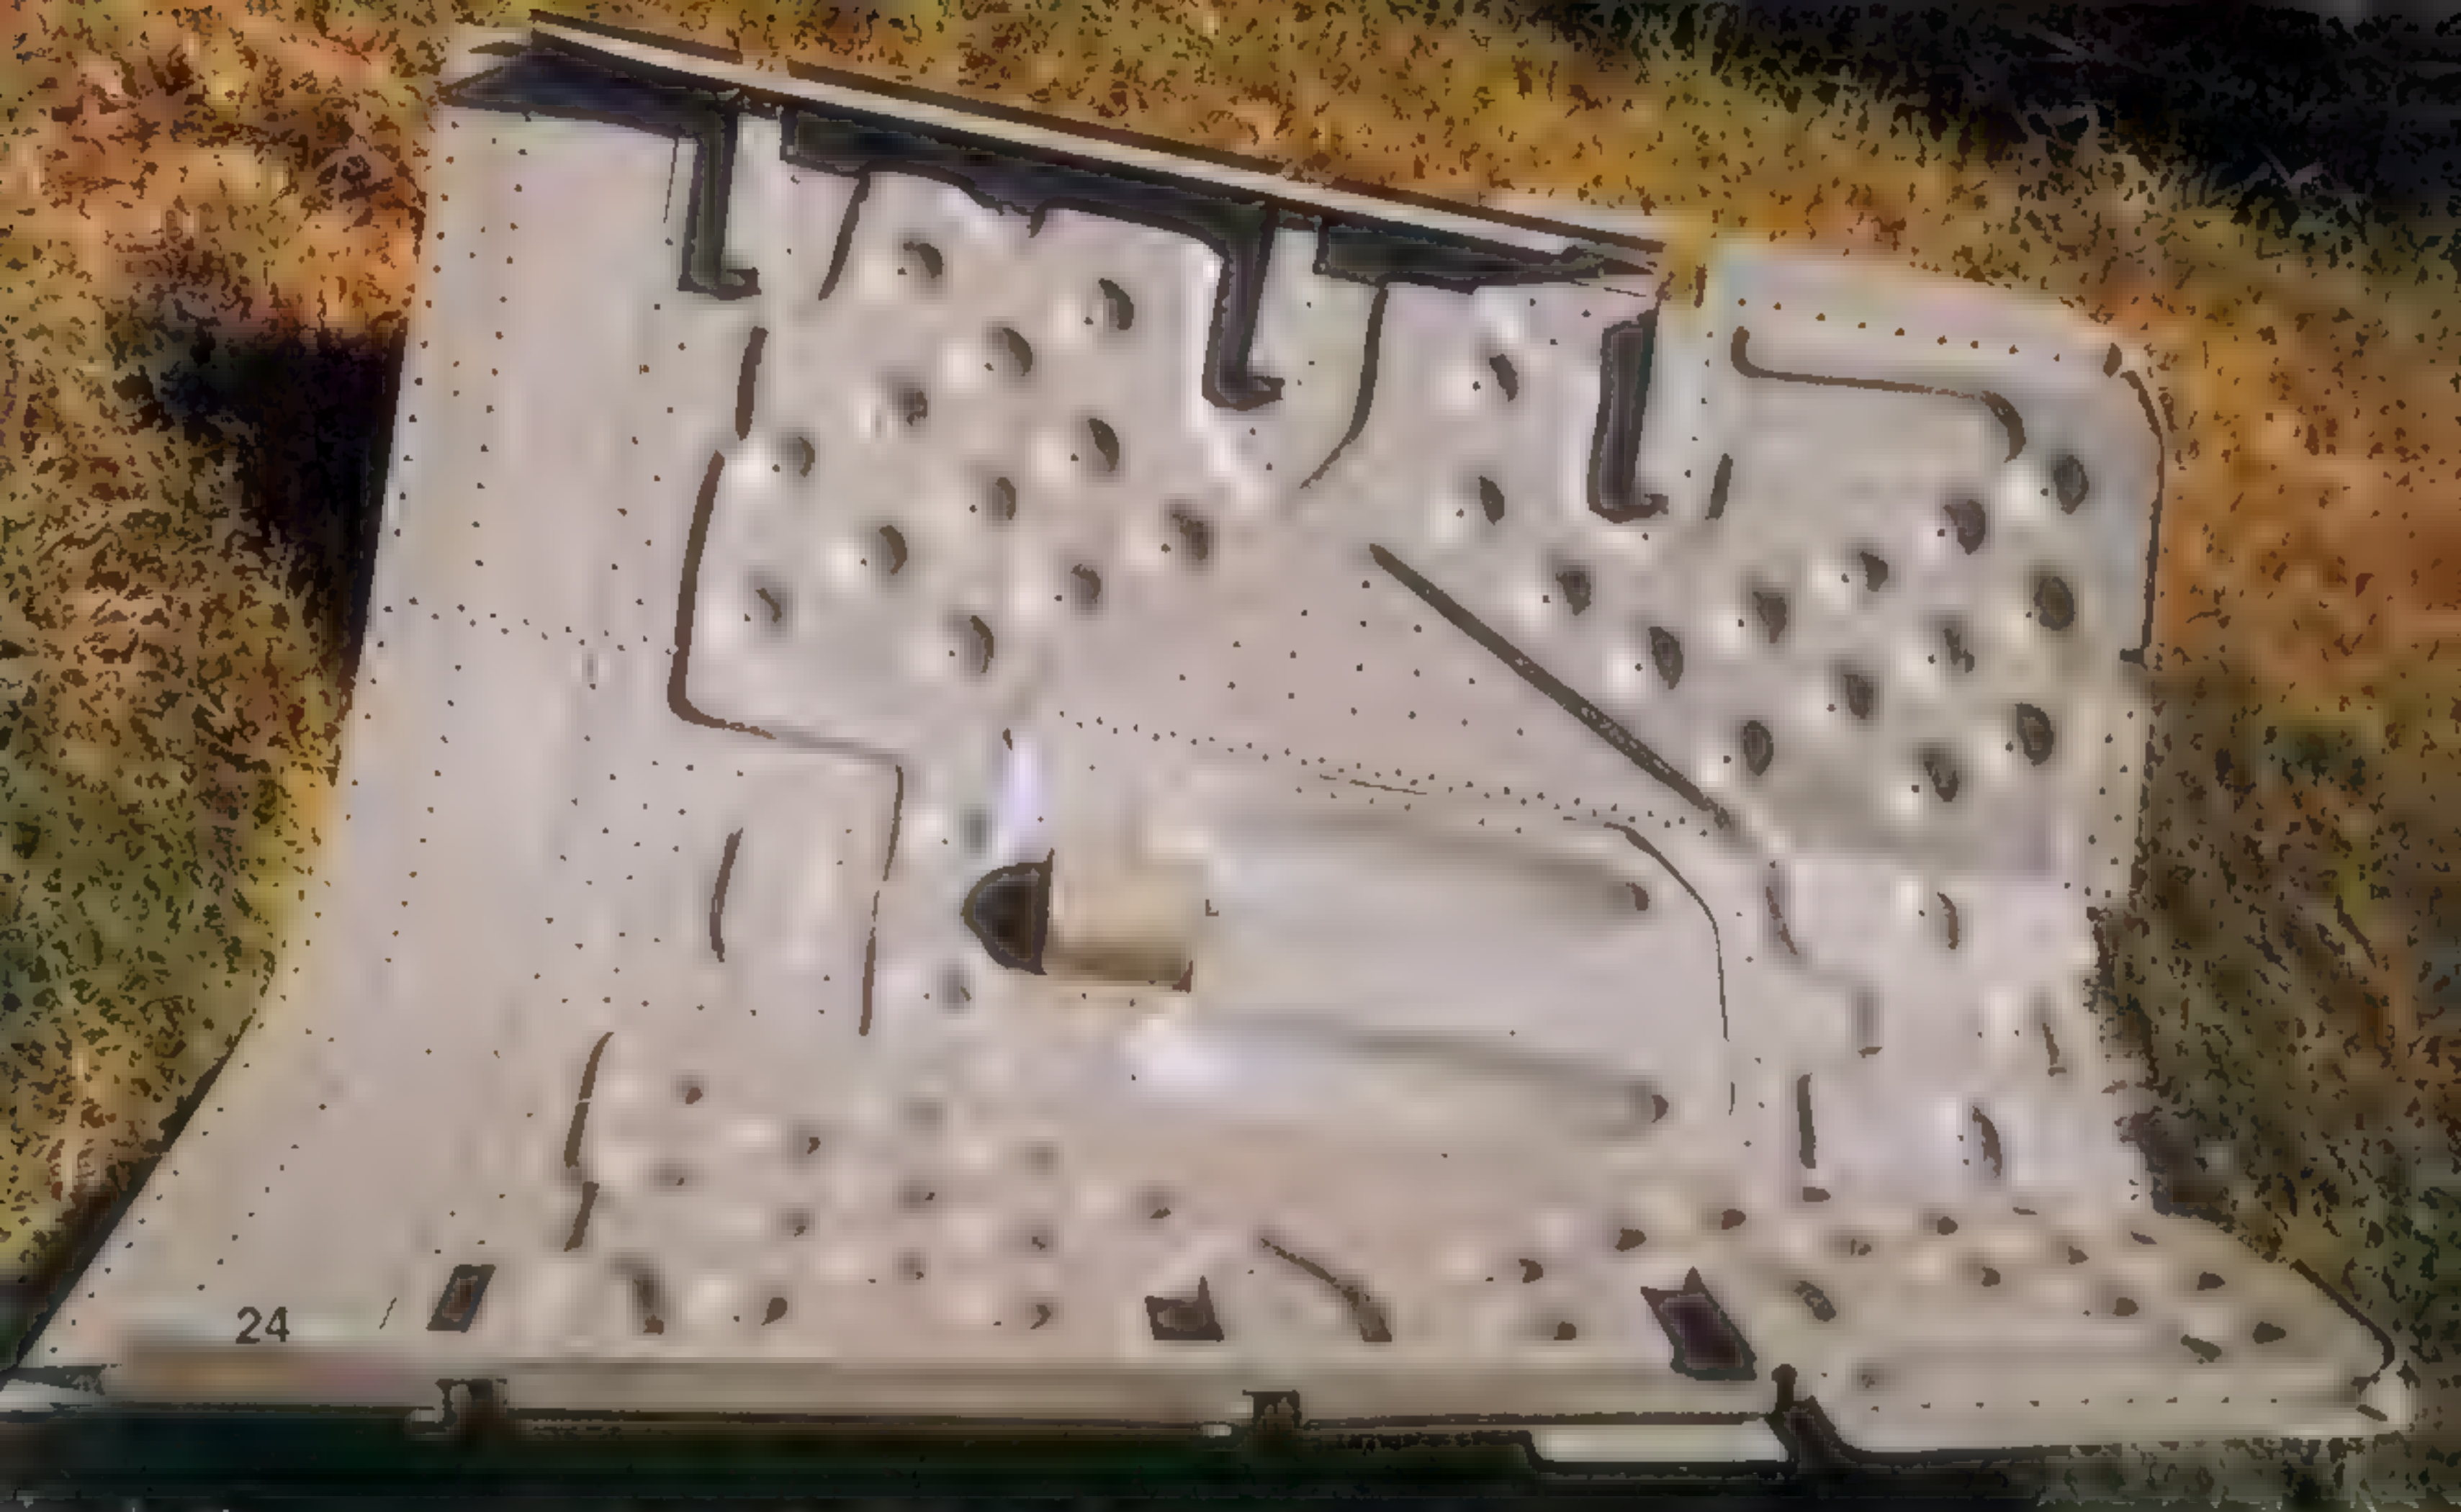
(Left) The interior of the Fw 190A-6 cowling machine gun cover displays the stamped 'dimple pattern' used to stiffen this panel on Fw 190A-0s through A-6s. The cylindrical object next to the two breech clearing depressions is the inside of the handhold, which was used to pull this panel open for servicing the guns. (Houston)

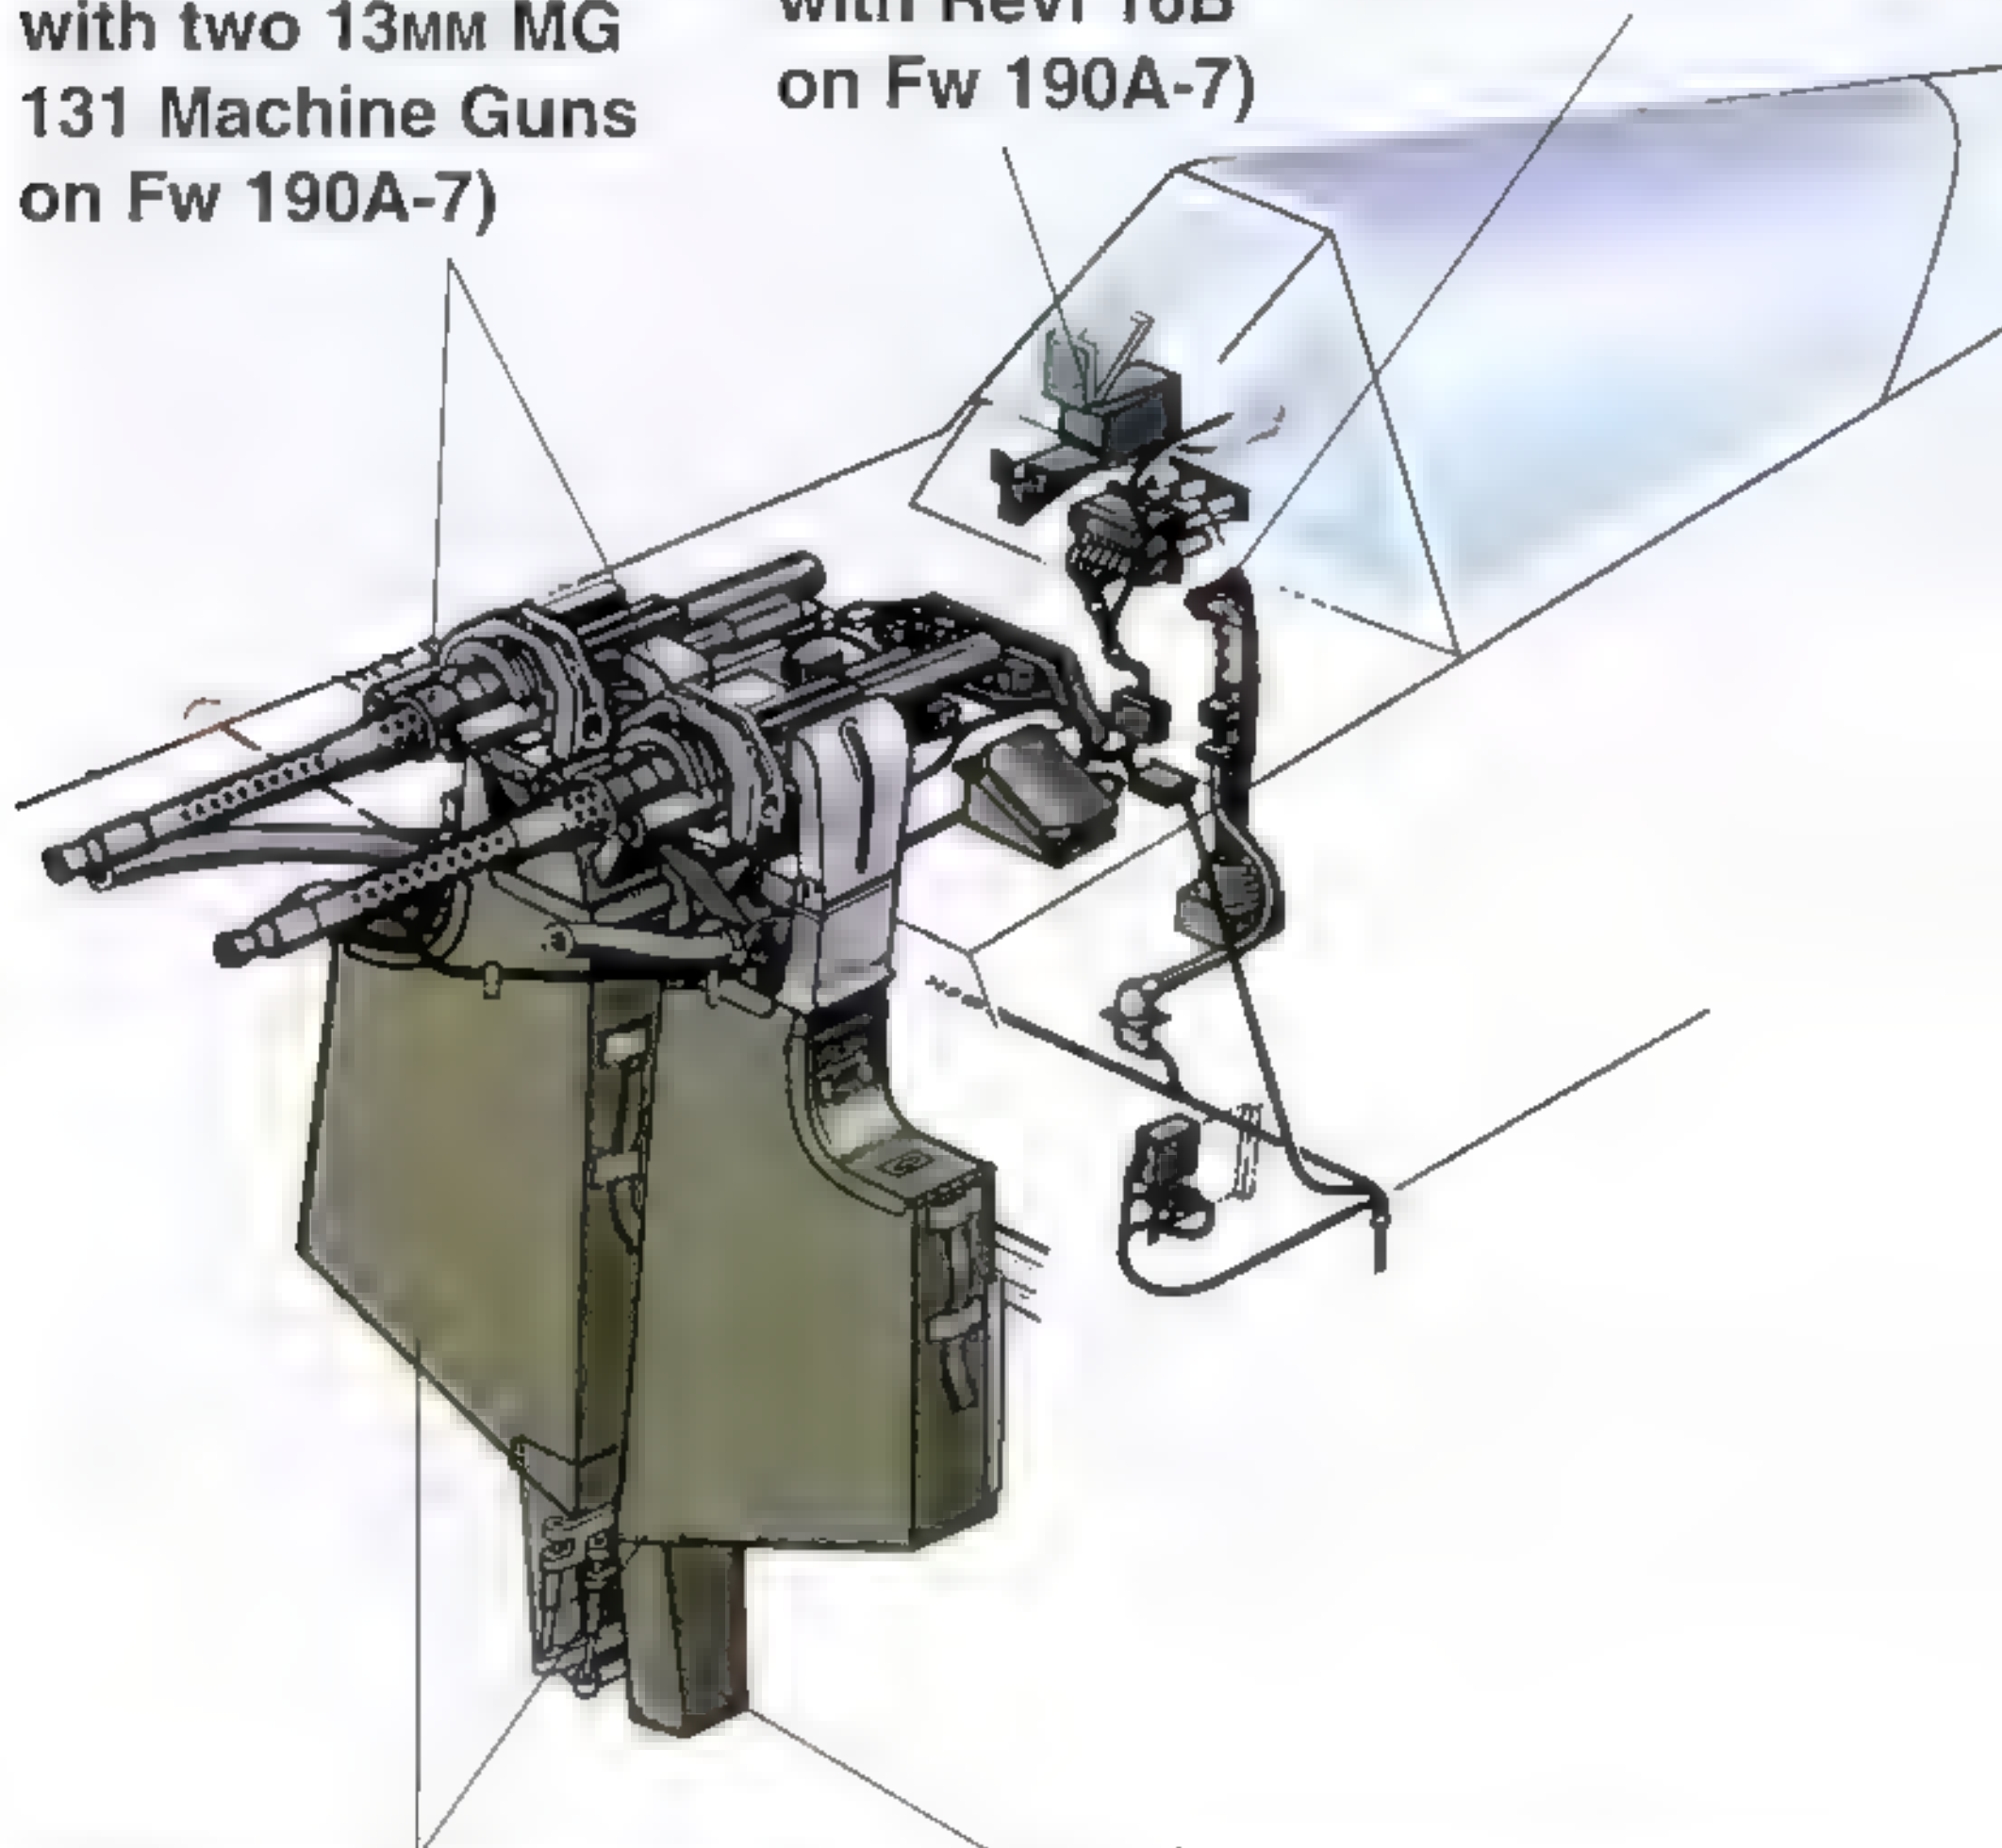
# Fw 190 Cowl Gun System

Rheinmetall 7.92MM  
MG 17 Machine  
Guns (2) (Replaced  
with two 13MM MG  
131 Machine Guns  
on Fw 190A-7)

Revi 12C/D  
Gunsight  
(Replaced  
with Revi 16B  
on Fw 190A-7)

Control Column with  
Machine Gun Firing  
Button on Grip

400-Round Magazines for  
MG 17s (2)

Ejection Chutes for  
Spent Cartridges (2)

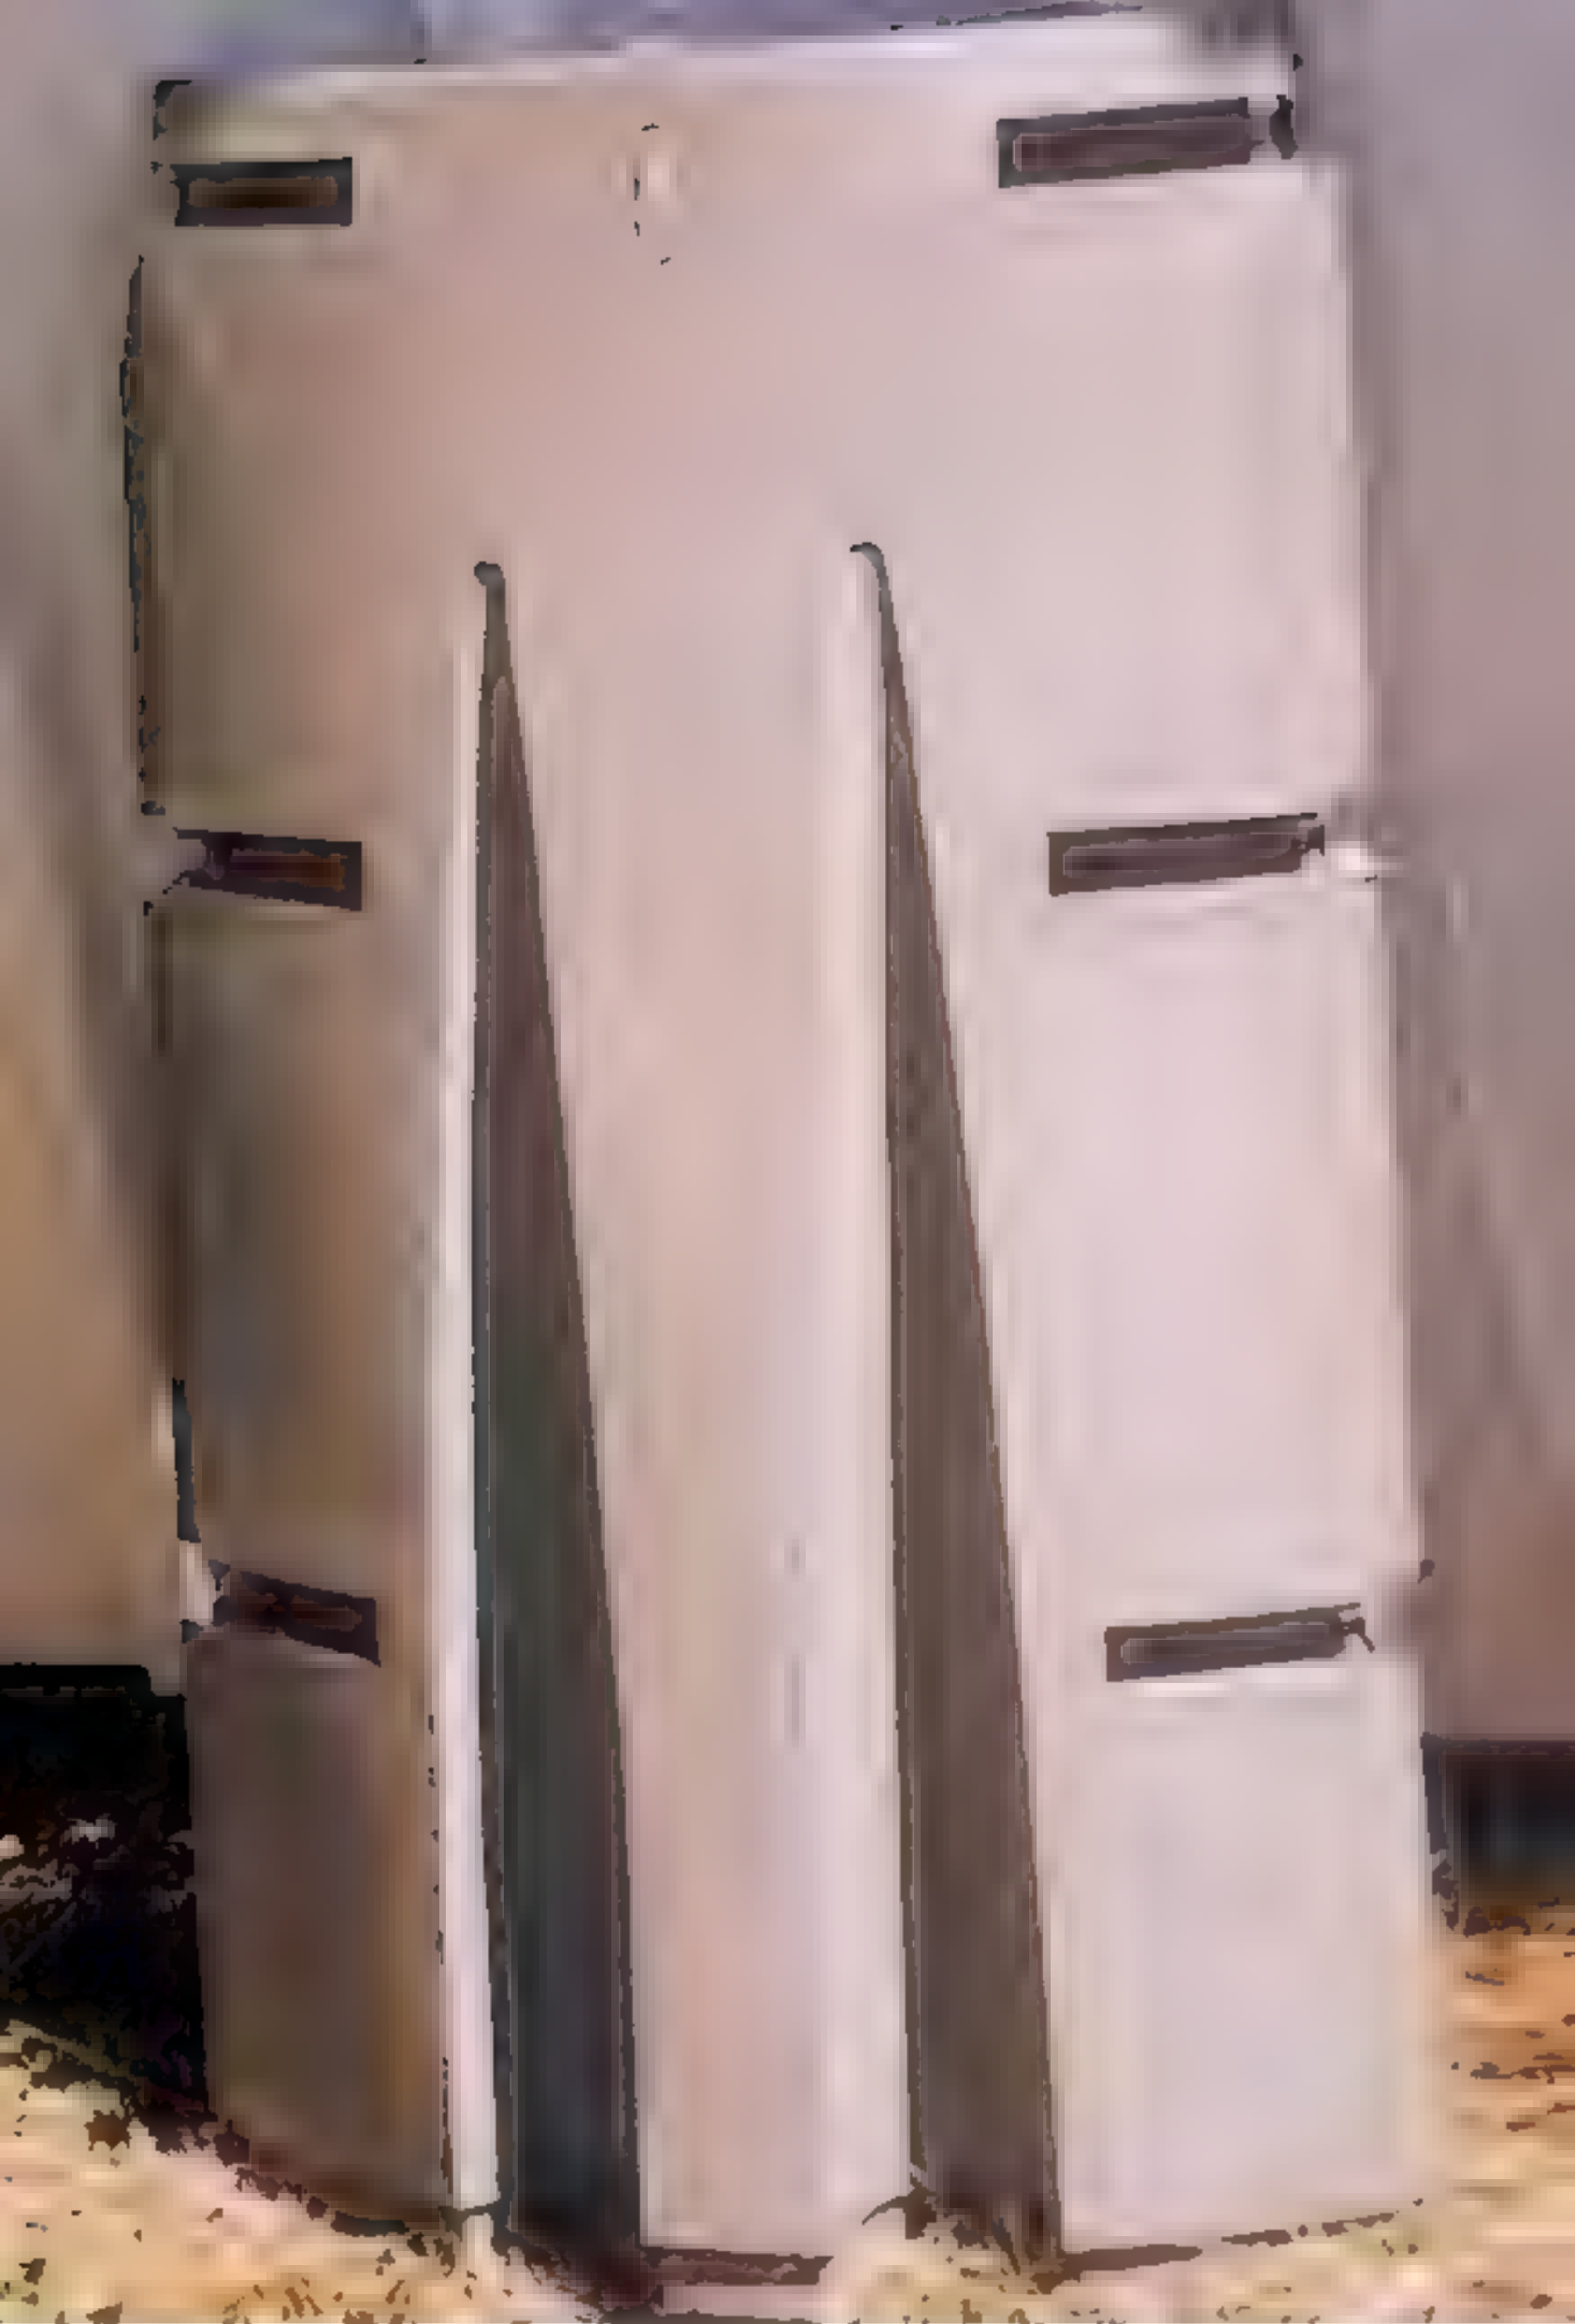
The two machine gun troughs dominate the upper engine cowling panel for the Fw 190A-8. The deepest portion of the troughs was placed at the aft end of this panel. The depth of the gun troughs and the round points at the forward portion of the troughs were standard for all Fw 190s. Openings for six latches line the sides of the panel, while a smaller latch is installed at its leading edge. (Houston)

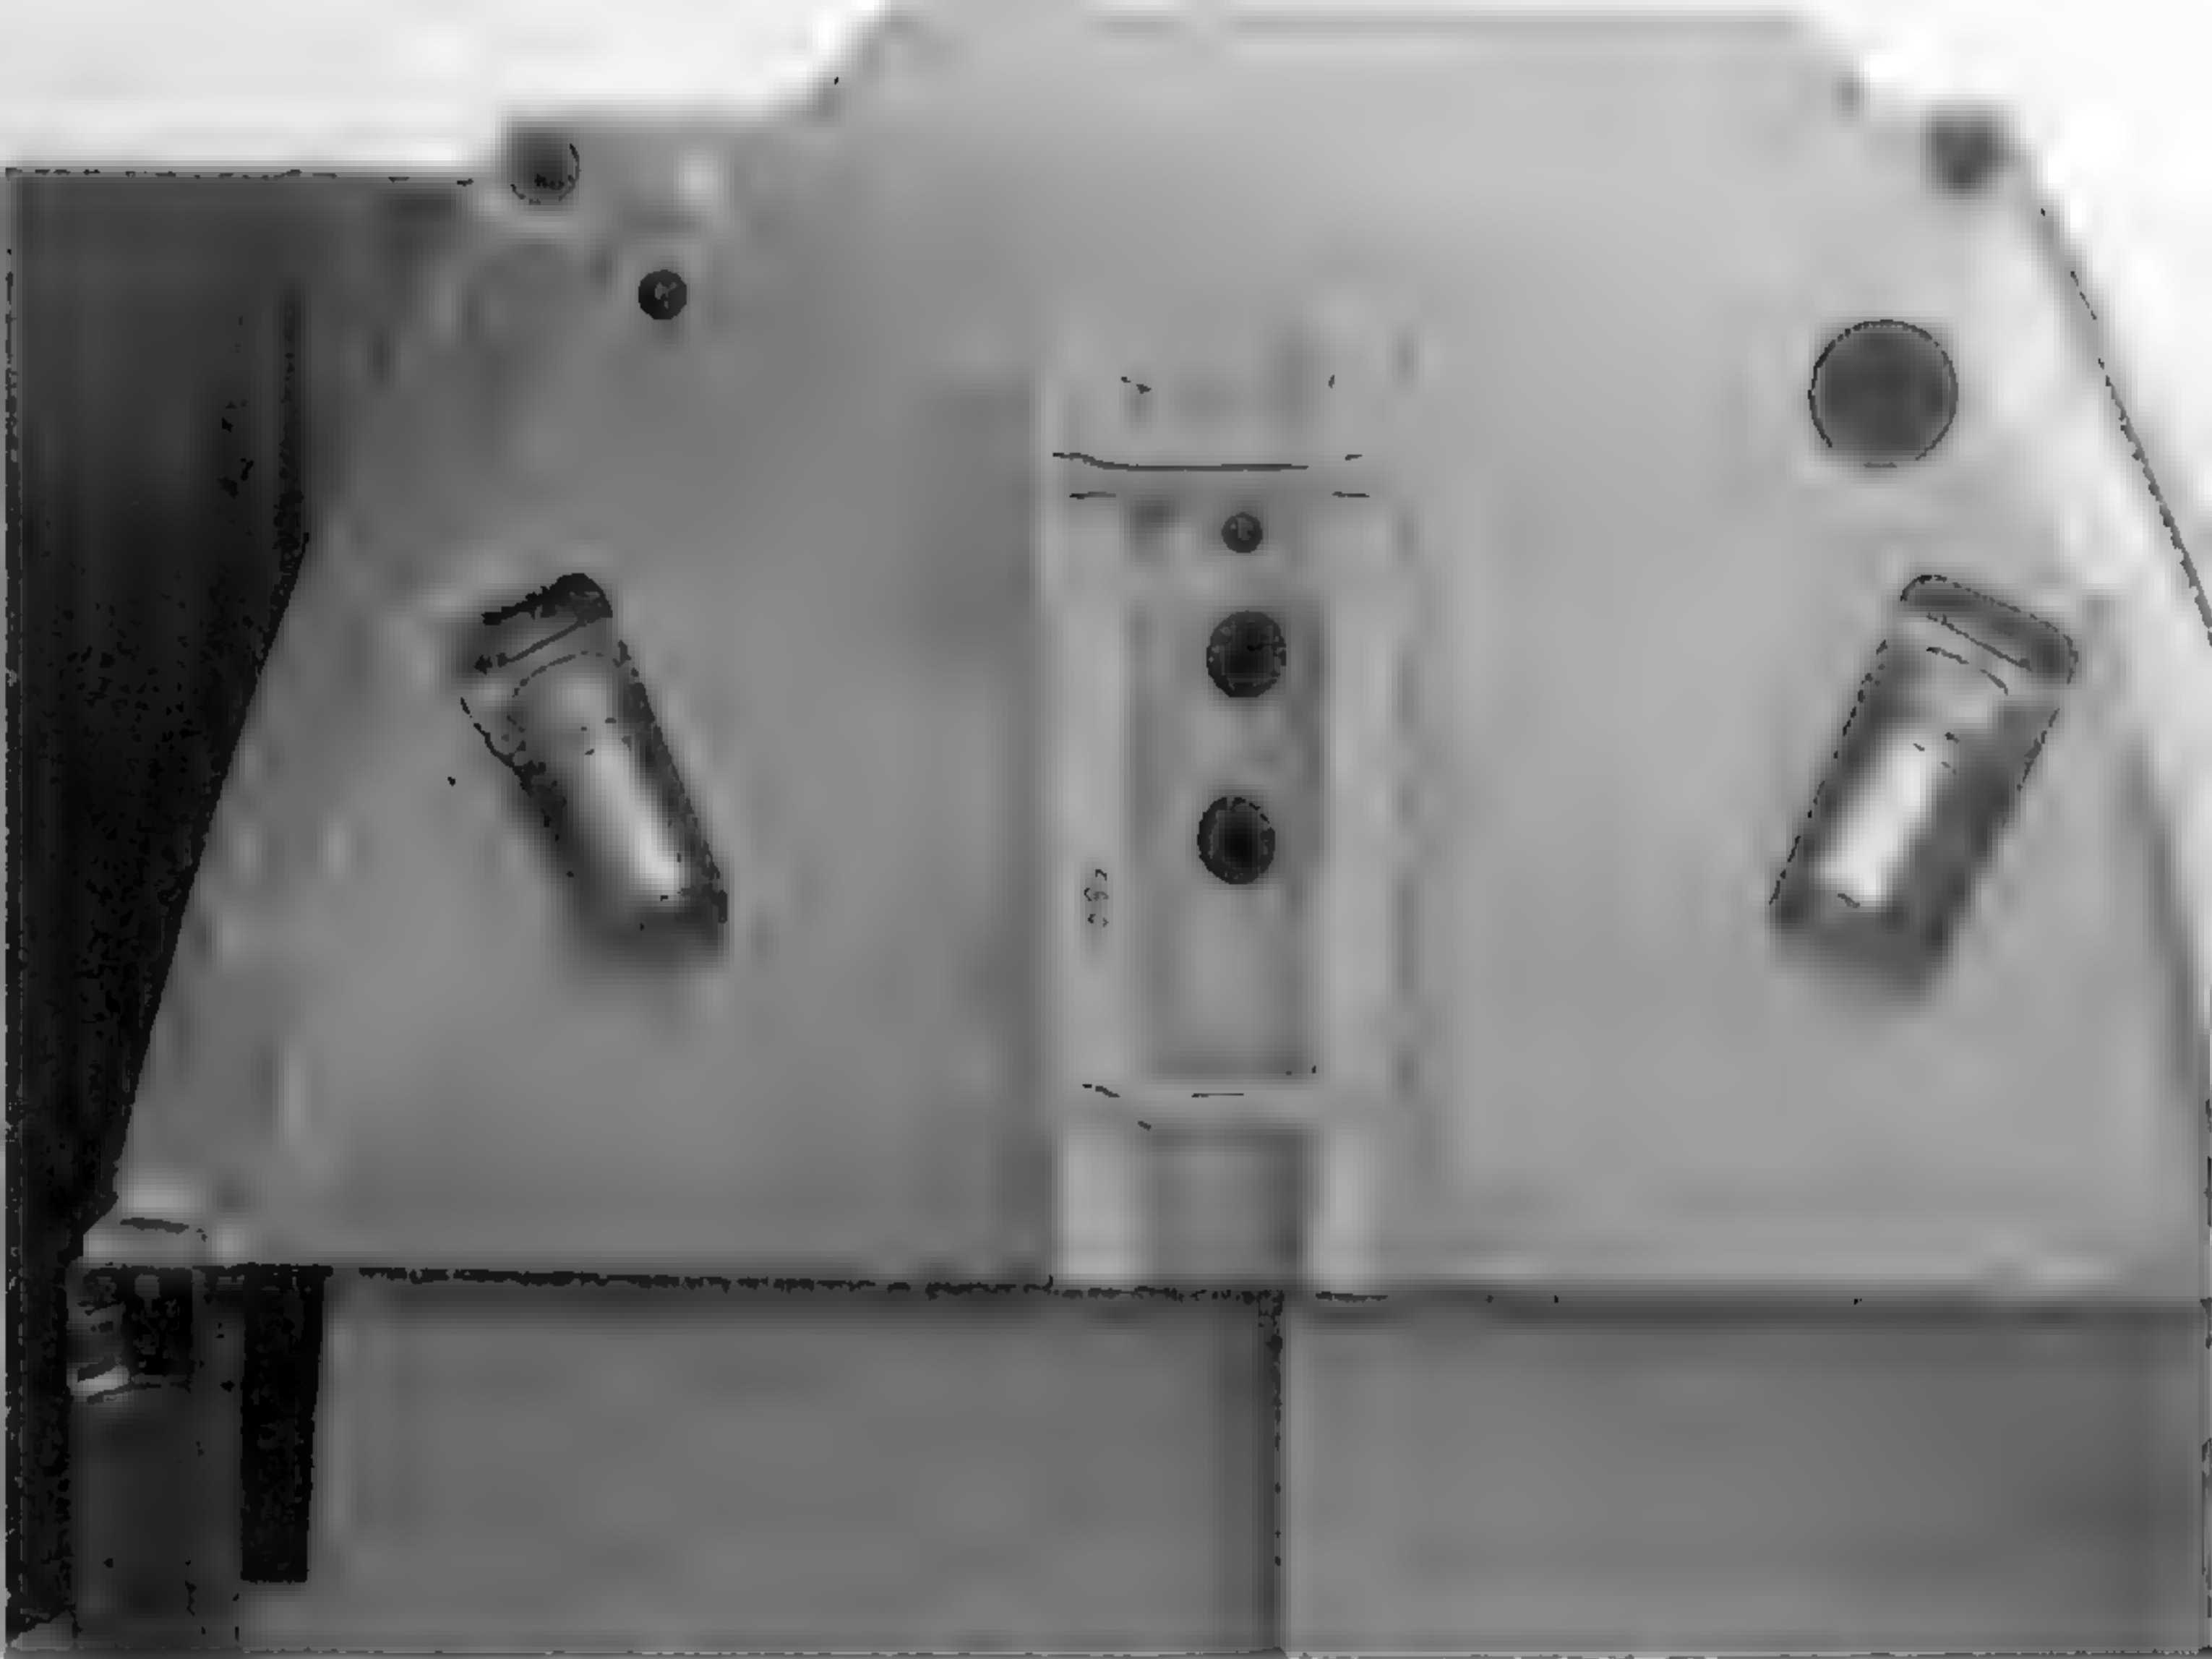
(Above) The engine bearer assembly has been removed from the firewall of the Fw 190A-8's fuselage. Two cylindrical fuel filters were installed in this bulkhead. Fuel drawn from tanks located in the lower fuselage passed through these filters before going on to the engine. The late war inside ammunition box brackets were placed in the center of the firewall. (Laing)
